Manhole Inspection Summary

Manhole # S21UU1B01MH

Location Address: **CROSS KEYS RD**

Cross Street: **I-83**

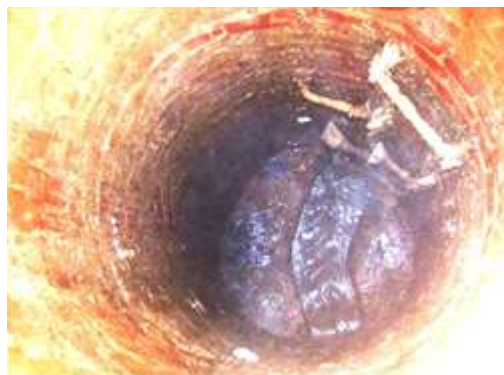
Top View

Adjustment, Corbel, and Barrel infiltration. Corroded steps. Evidence of surcharge - Bench debris.

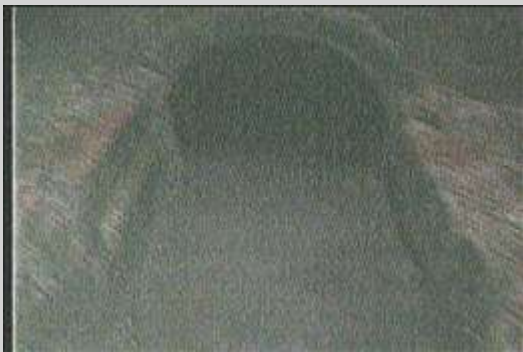
15 in. Circular Gravity Sewer Pipe Out @ 12 O'Clock

Infiltration: **None** Pipe Seal Cond: **Unknown**

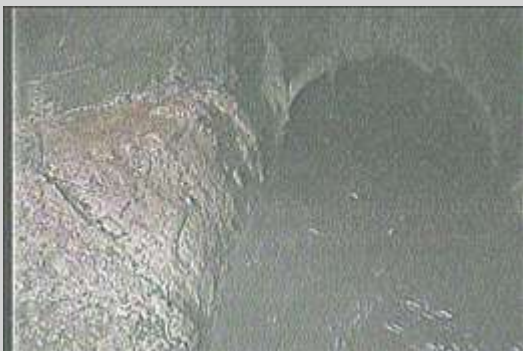
15 in. Circular Gravity Sewer Pipe In @ 4 O'Clock

Infiltration: **None** Pipe Seal Cond: **Unknown**
